FINAL SITE INSPECTION REPORT

CPG KICKOUT AREA

LOUISIANA ARMY NATIONAL GUARD
CAMP MINDEN, LOUISIANA

JUNE 2014

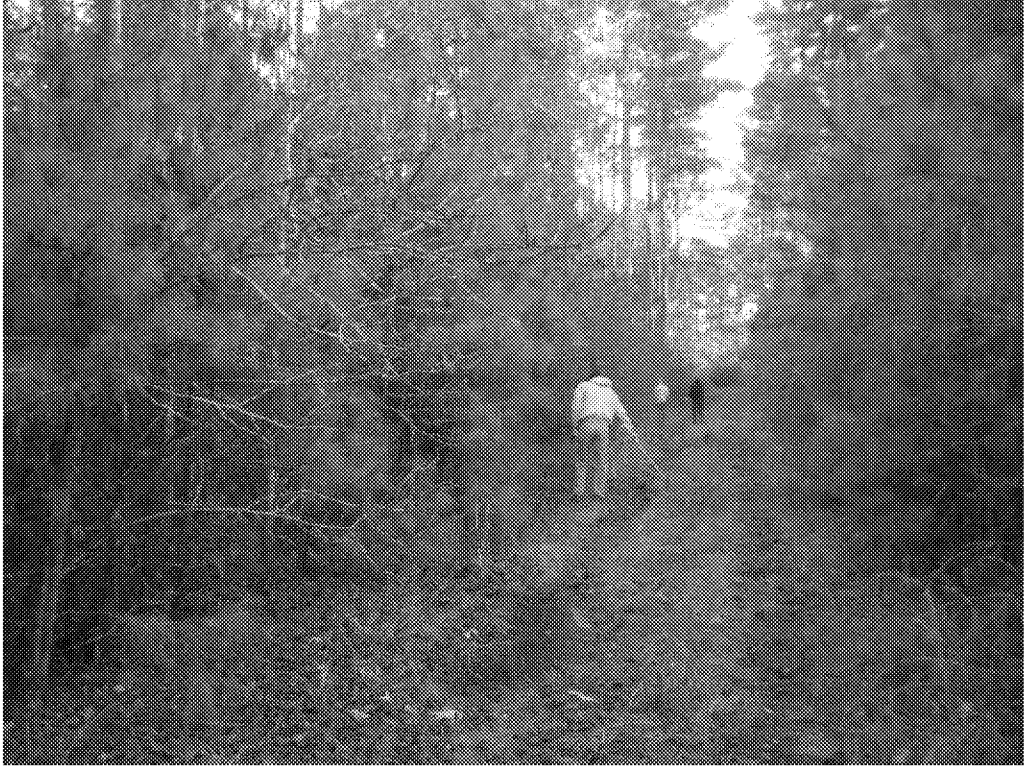
Client Name: USACE – Fort Worth District		Site Location: Camp Minden Army National Guard, Louisiana	Project No. 1293
Photo No. 1	Date: 1/15/14

Direction Photo Taken: Northeast			
Description: View of field survey team completing transect 32.

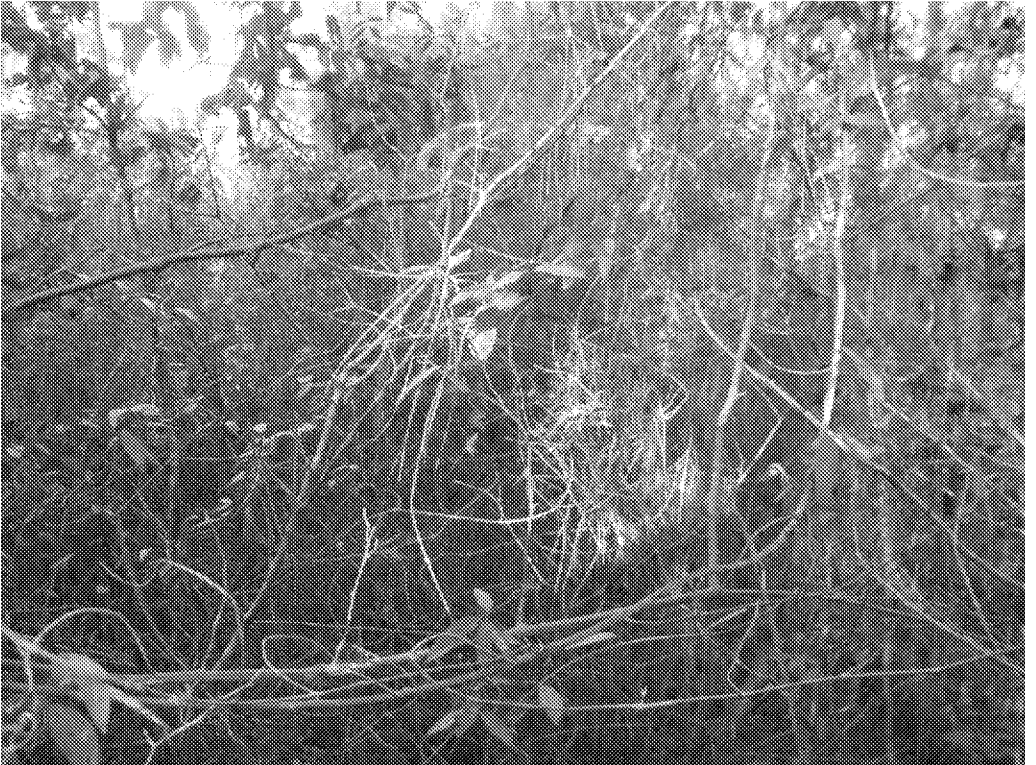
Photo No. 2	Date: 1/15/14

Direction Photo Taken: North		
Description: View of heavily wooded area along the western boundary of CPG Kickout Area.

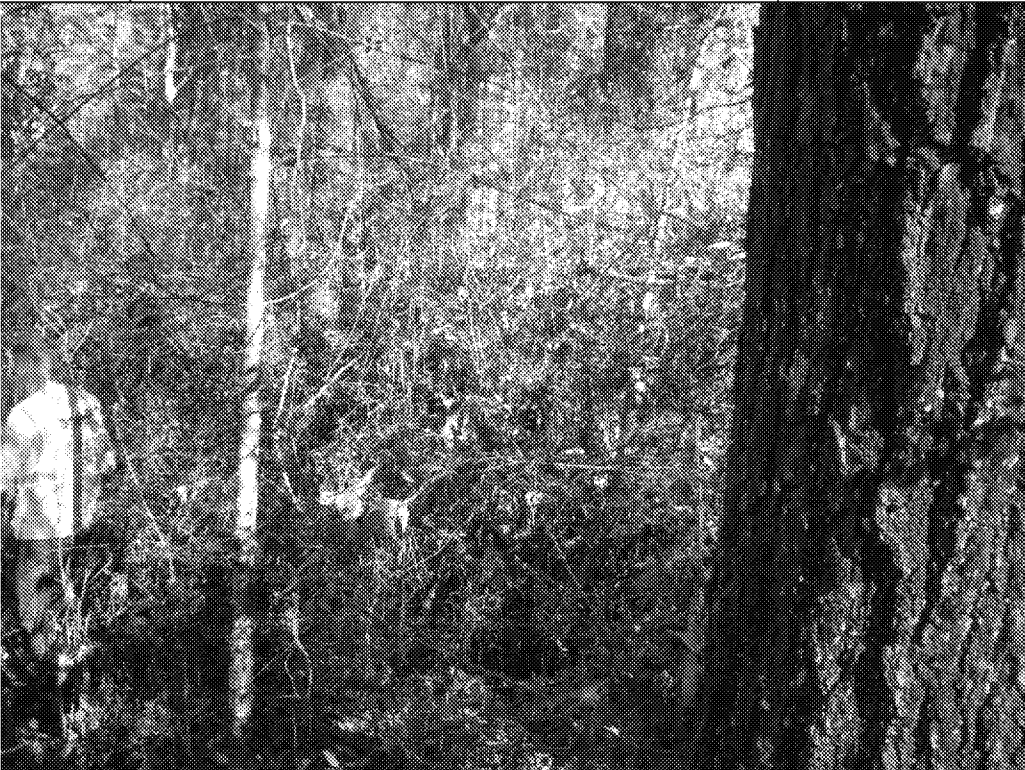
Client Name: USACE – Fort Worth District		Site Location: Camp Minden Army National Guard, Louisiana	Project No. 1293
Photo No. 3	Date: 1/15/14

Direction Photo Taken: North			
Description: View of heavily vegetated area along transect 24.

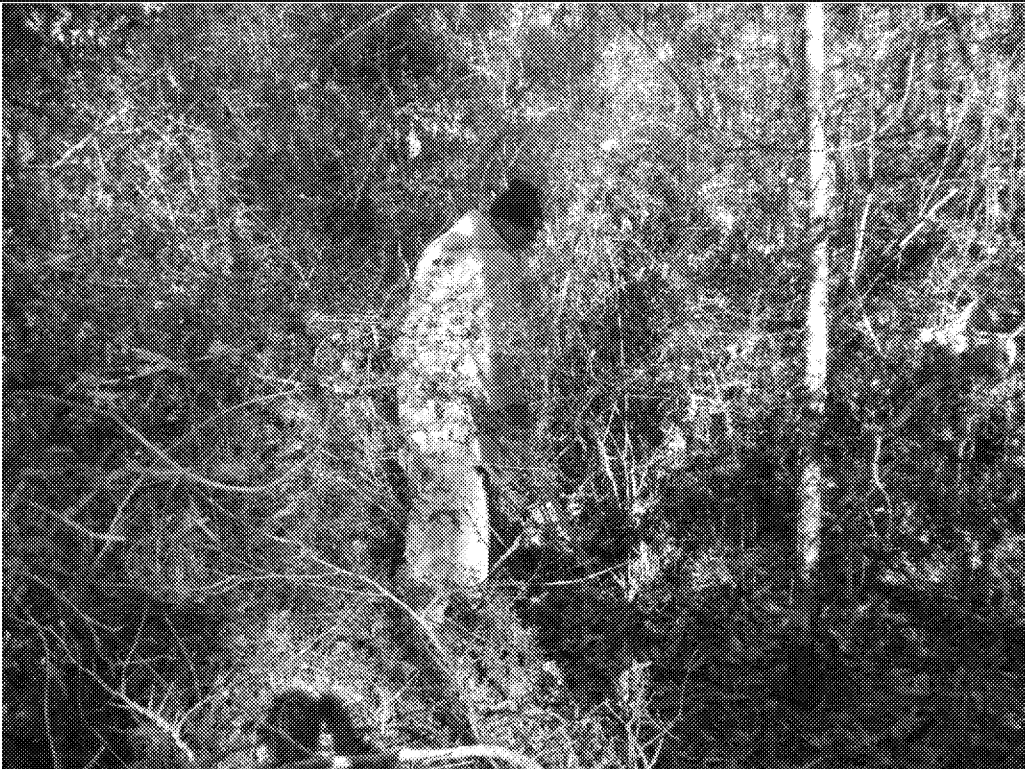
Photo No. 4	Date: 1/15/14

Direction Photo Taken: North		
Description: View of UXO Tech III using a Schonstedt GA-52cx Magnetic Locator to survey for metallic anomalies along transect 24.

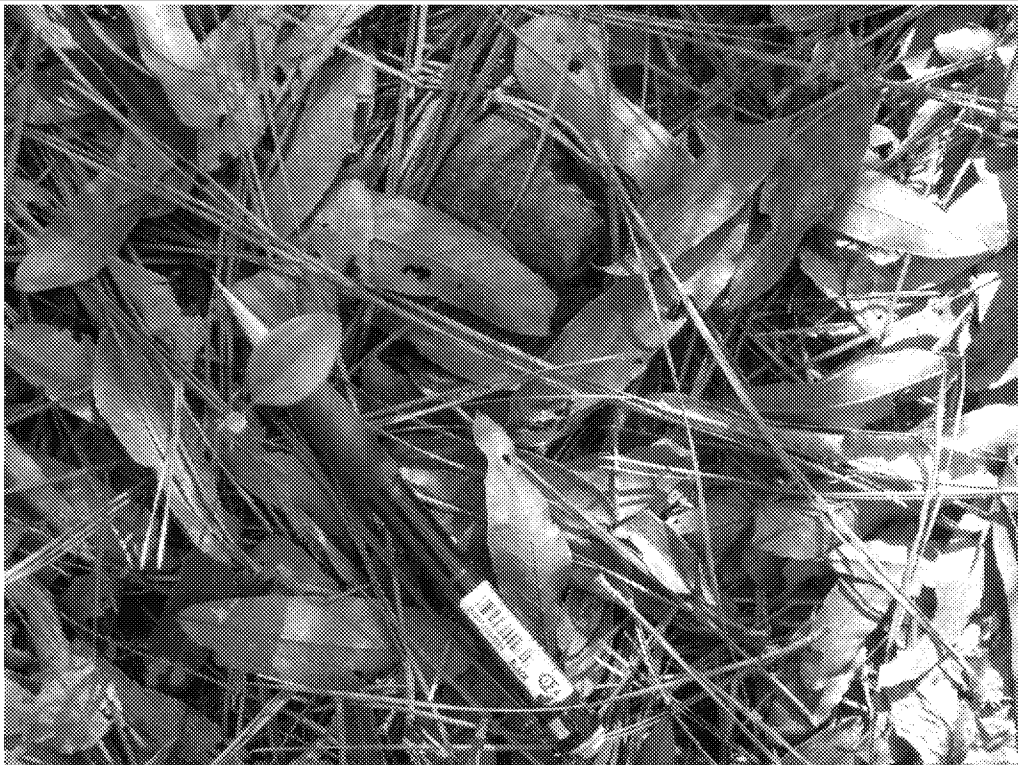
Client Name: USACE – Fort Worth District		Site Location: Camp Minden Army National Guard, Louisiana	Project No. 1293
Photo No. 5	Date: 1/15/14

Direction Photo Taken: N/A			
Description: View of a bomb fuze located on the surface along transect 21.

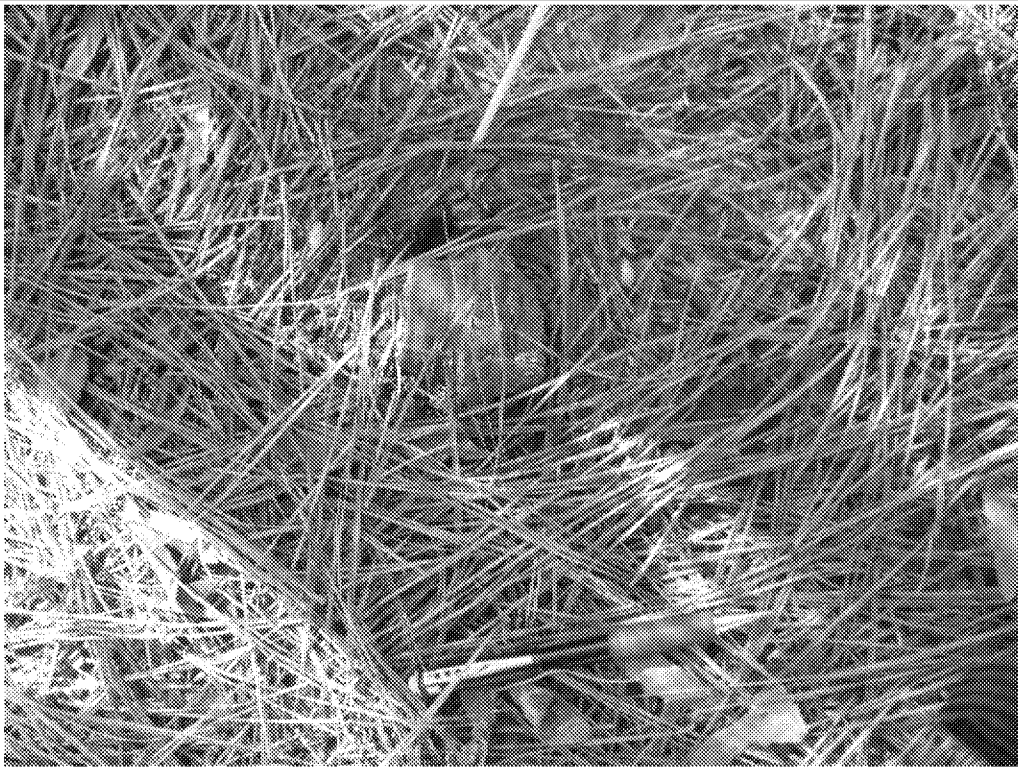
Client Name: USACE – Fort Worth District		Site Location: Camp Minden Army National Guard, Louisiana	Project No. 1293
Photo No. 7	Date: 1/15/14

Direction Photo Taken: N/A			
Description: View of a bomb fuze located on the surface along transect 14.

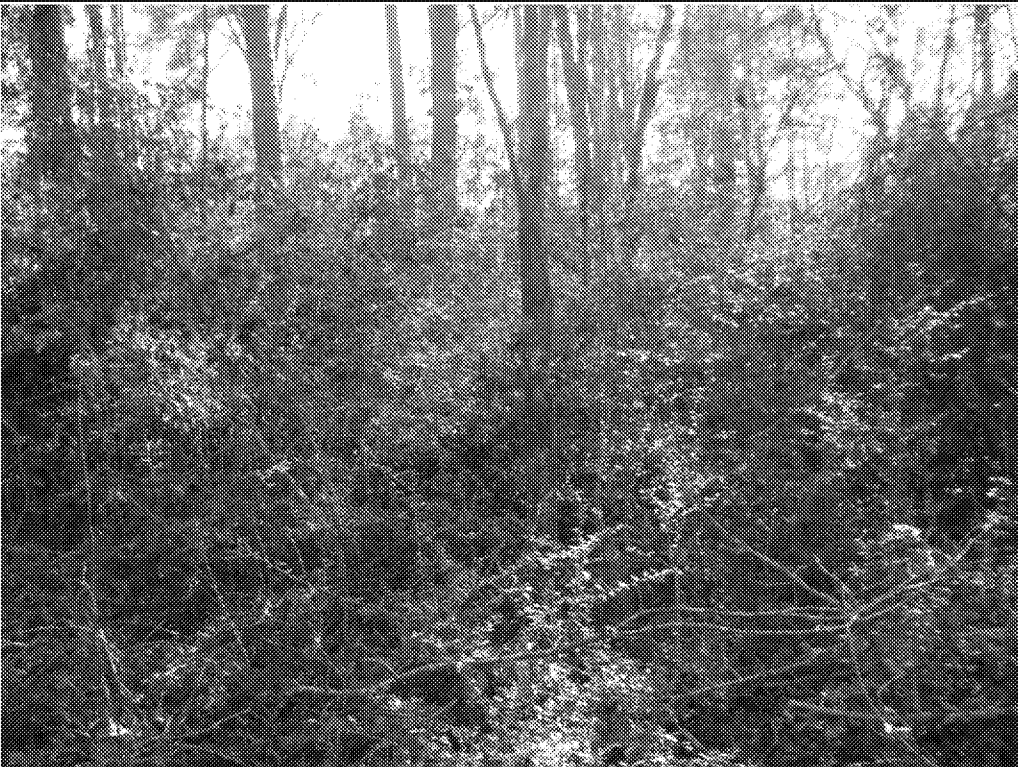
Photo No. 8	Date: 1/15/14

Direction Photo Taken: South		
Description: View of heavily vegetated area along transect 10.

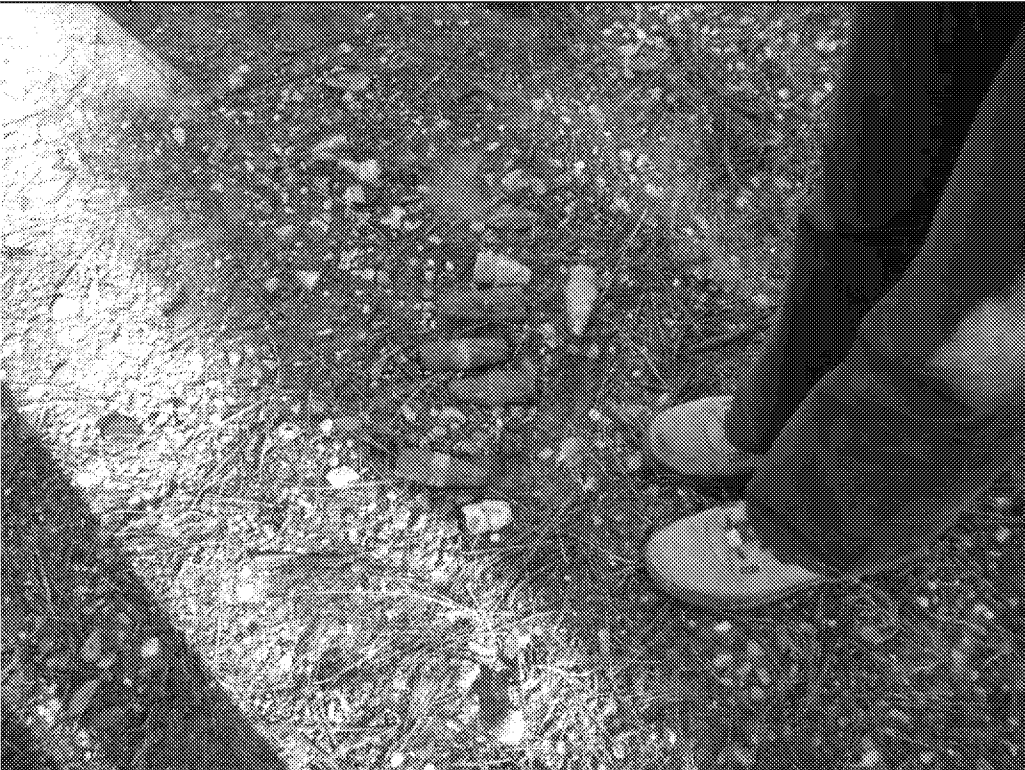
Client Name: USACE – Fort Worth District		Site Location: Camp Minden Army National Guard, Louisiana	Project No. 1293
Photo No. 9	Date: 1/15/14

Direction Photo Taken: N/A			
Description: View of projectiles piled on the surface of the OB/OD within the CPG Kickout Area.

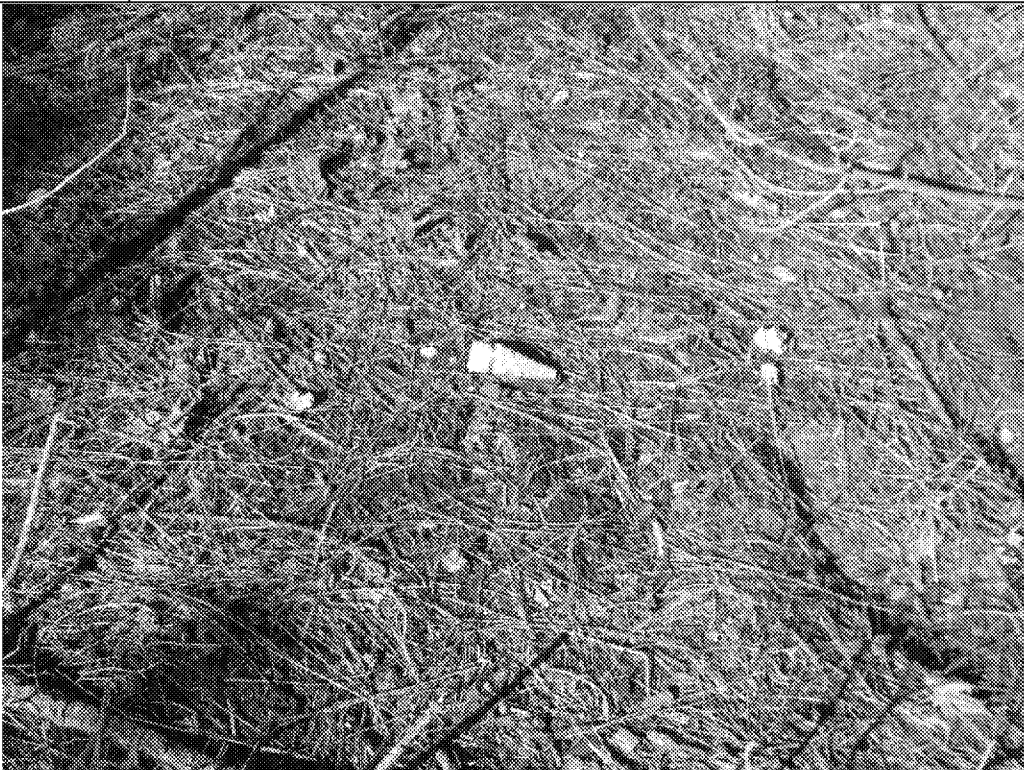
Client Name: USACE – Fort Worth District		Site Location: Camp Minden Army National Guard, Louisiana	Project No. 1293
Photo No. 11	Date: 1/15/14

Direction Photo Taken: N/A			
Description: View of projectile on the surface of the former OB/OD within the CPG Kickout Area.

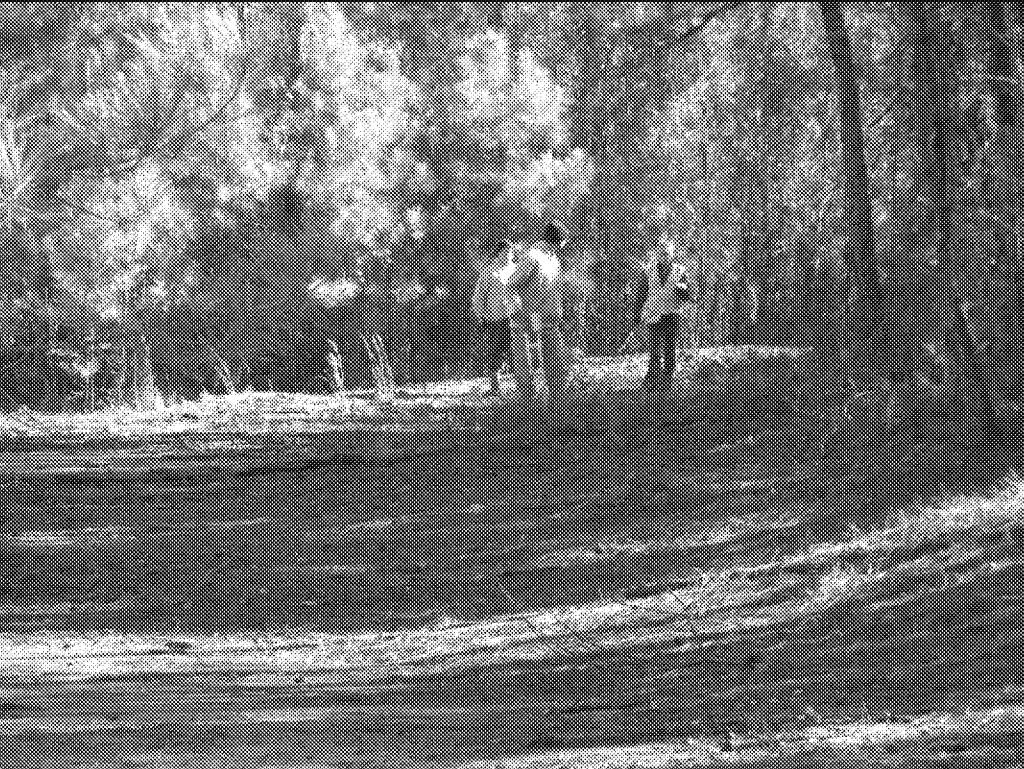
Photo No. 12	Date: 1/15/14

Direction Photo Taken: East		
Description: View of field survey team completing transect B-2.

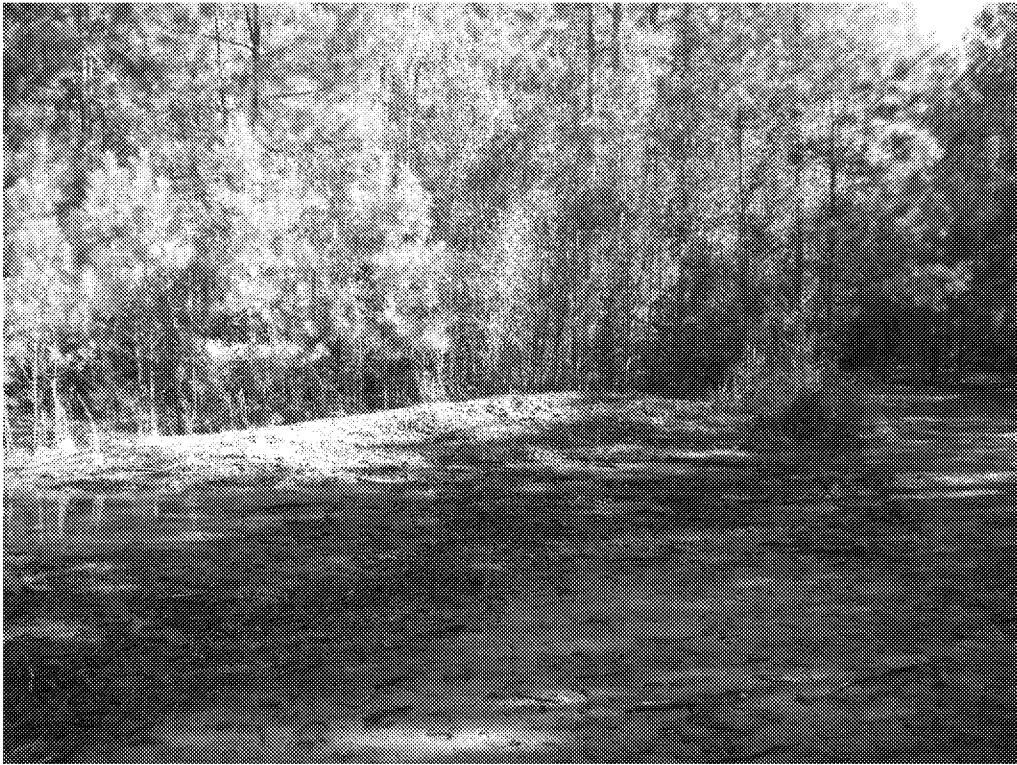
Client Name: USACE – Fort Worth District		Site Location: Camp Minden Army National Guard, Louisiana	Project No. 1293
Photo No. 13	Date: 1/15/14

Direction Photo Taken: East			
Description: View of clearing and small berm within the former OB/OD in the CPG Kickout Area.

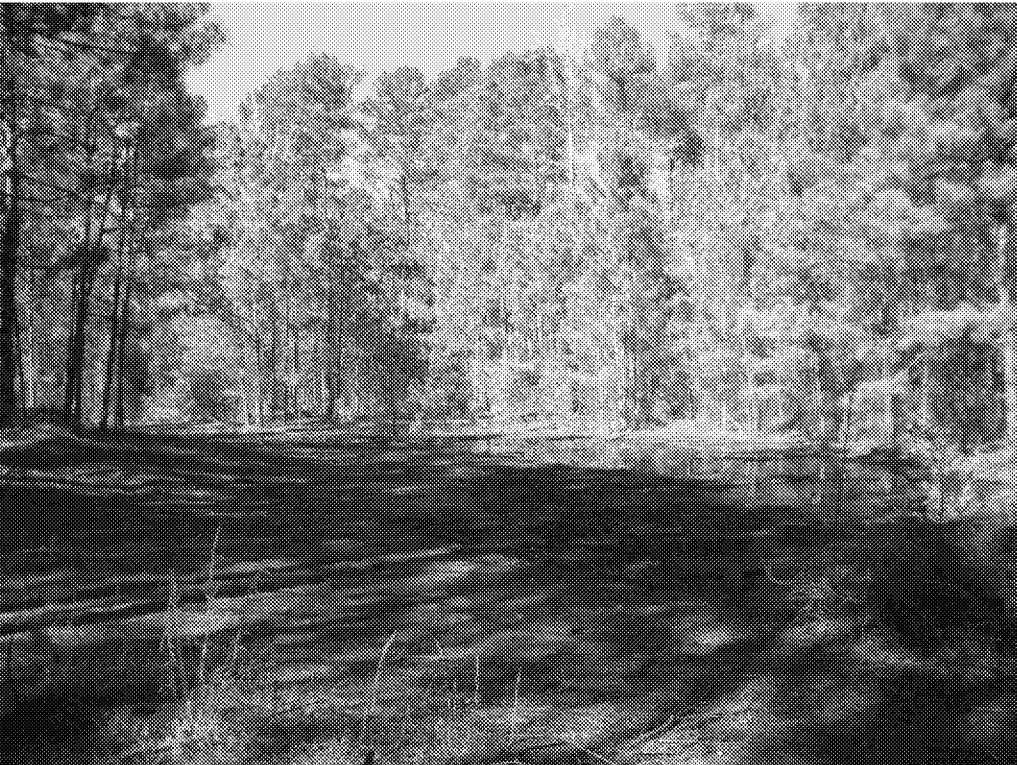
Photo No. 14	Date: 1/15/14

Direction Photo Taken: Northwest		
Description: View of clearing and small berm within the former OB/OD within the CPG Kickout Area. Notice the water filled crater in the center of the fenced in area.

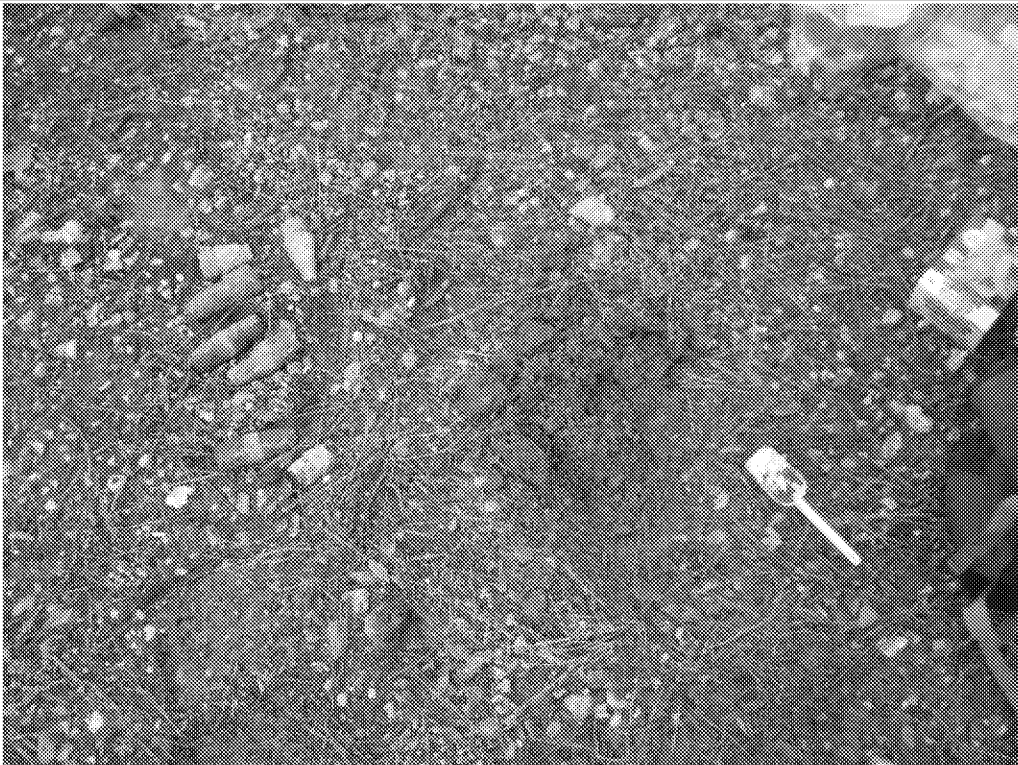
Client Name: USACE – Fort Worth District		Site Location: Camp Minden Army National Guard, Louisiana	Project No. 1293
Photo No. 15	Date: 1/15/14

Direction Photo Taken: N/A			
Description: View of sample location CM-02 collected adjacent to a pile of projectiles.

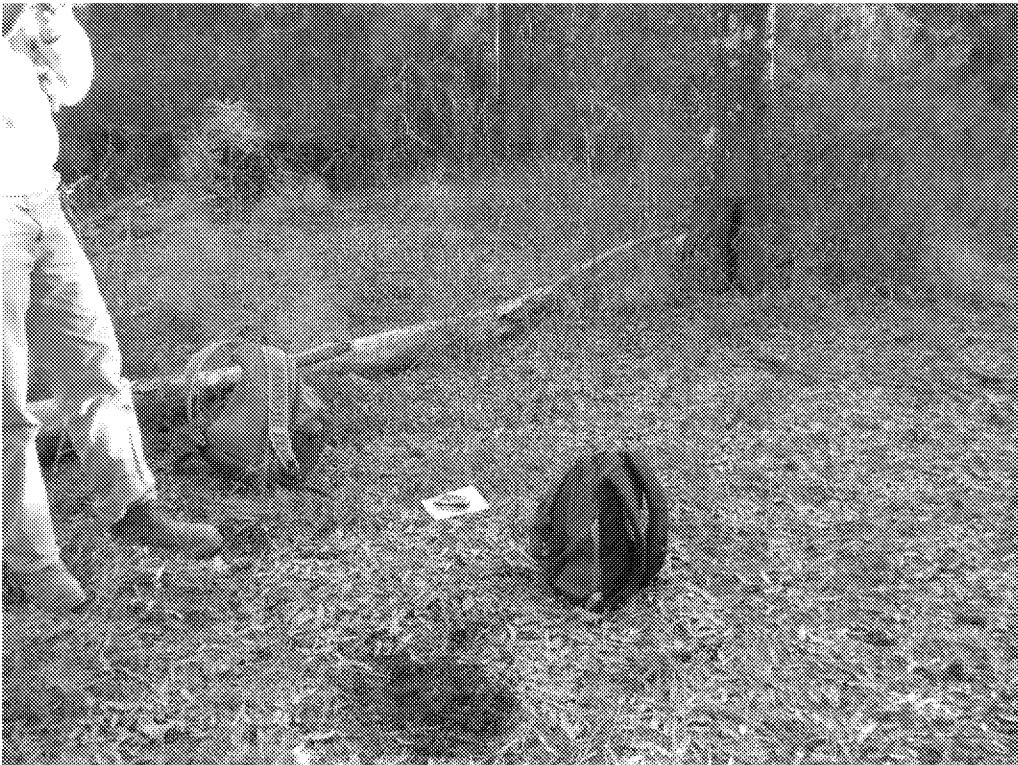
Photo No. 16	Date: 1/15/14

Direction Photo Taken: Southeast		
Description: View of sample location CM-03 collected within a multiple anomaly location.
